**JUBILEE PARK, ROGERSTONE - LAND
PARCELS LC1 & LC2**

**Geoenvironmental & Geotechnical
Assessment**

11183/RB/21/LC1&LC2

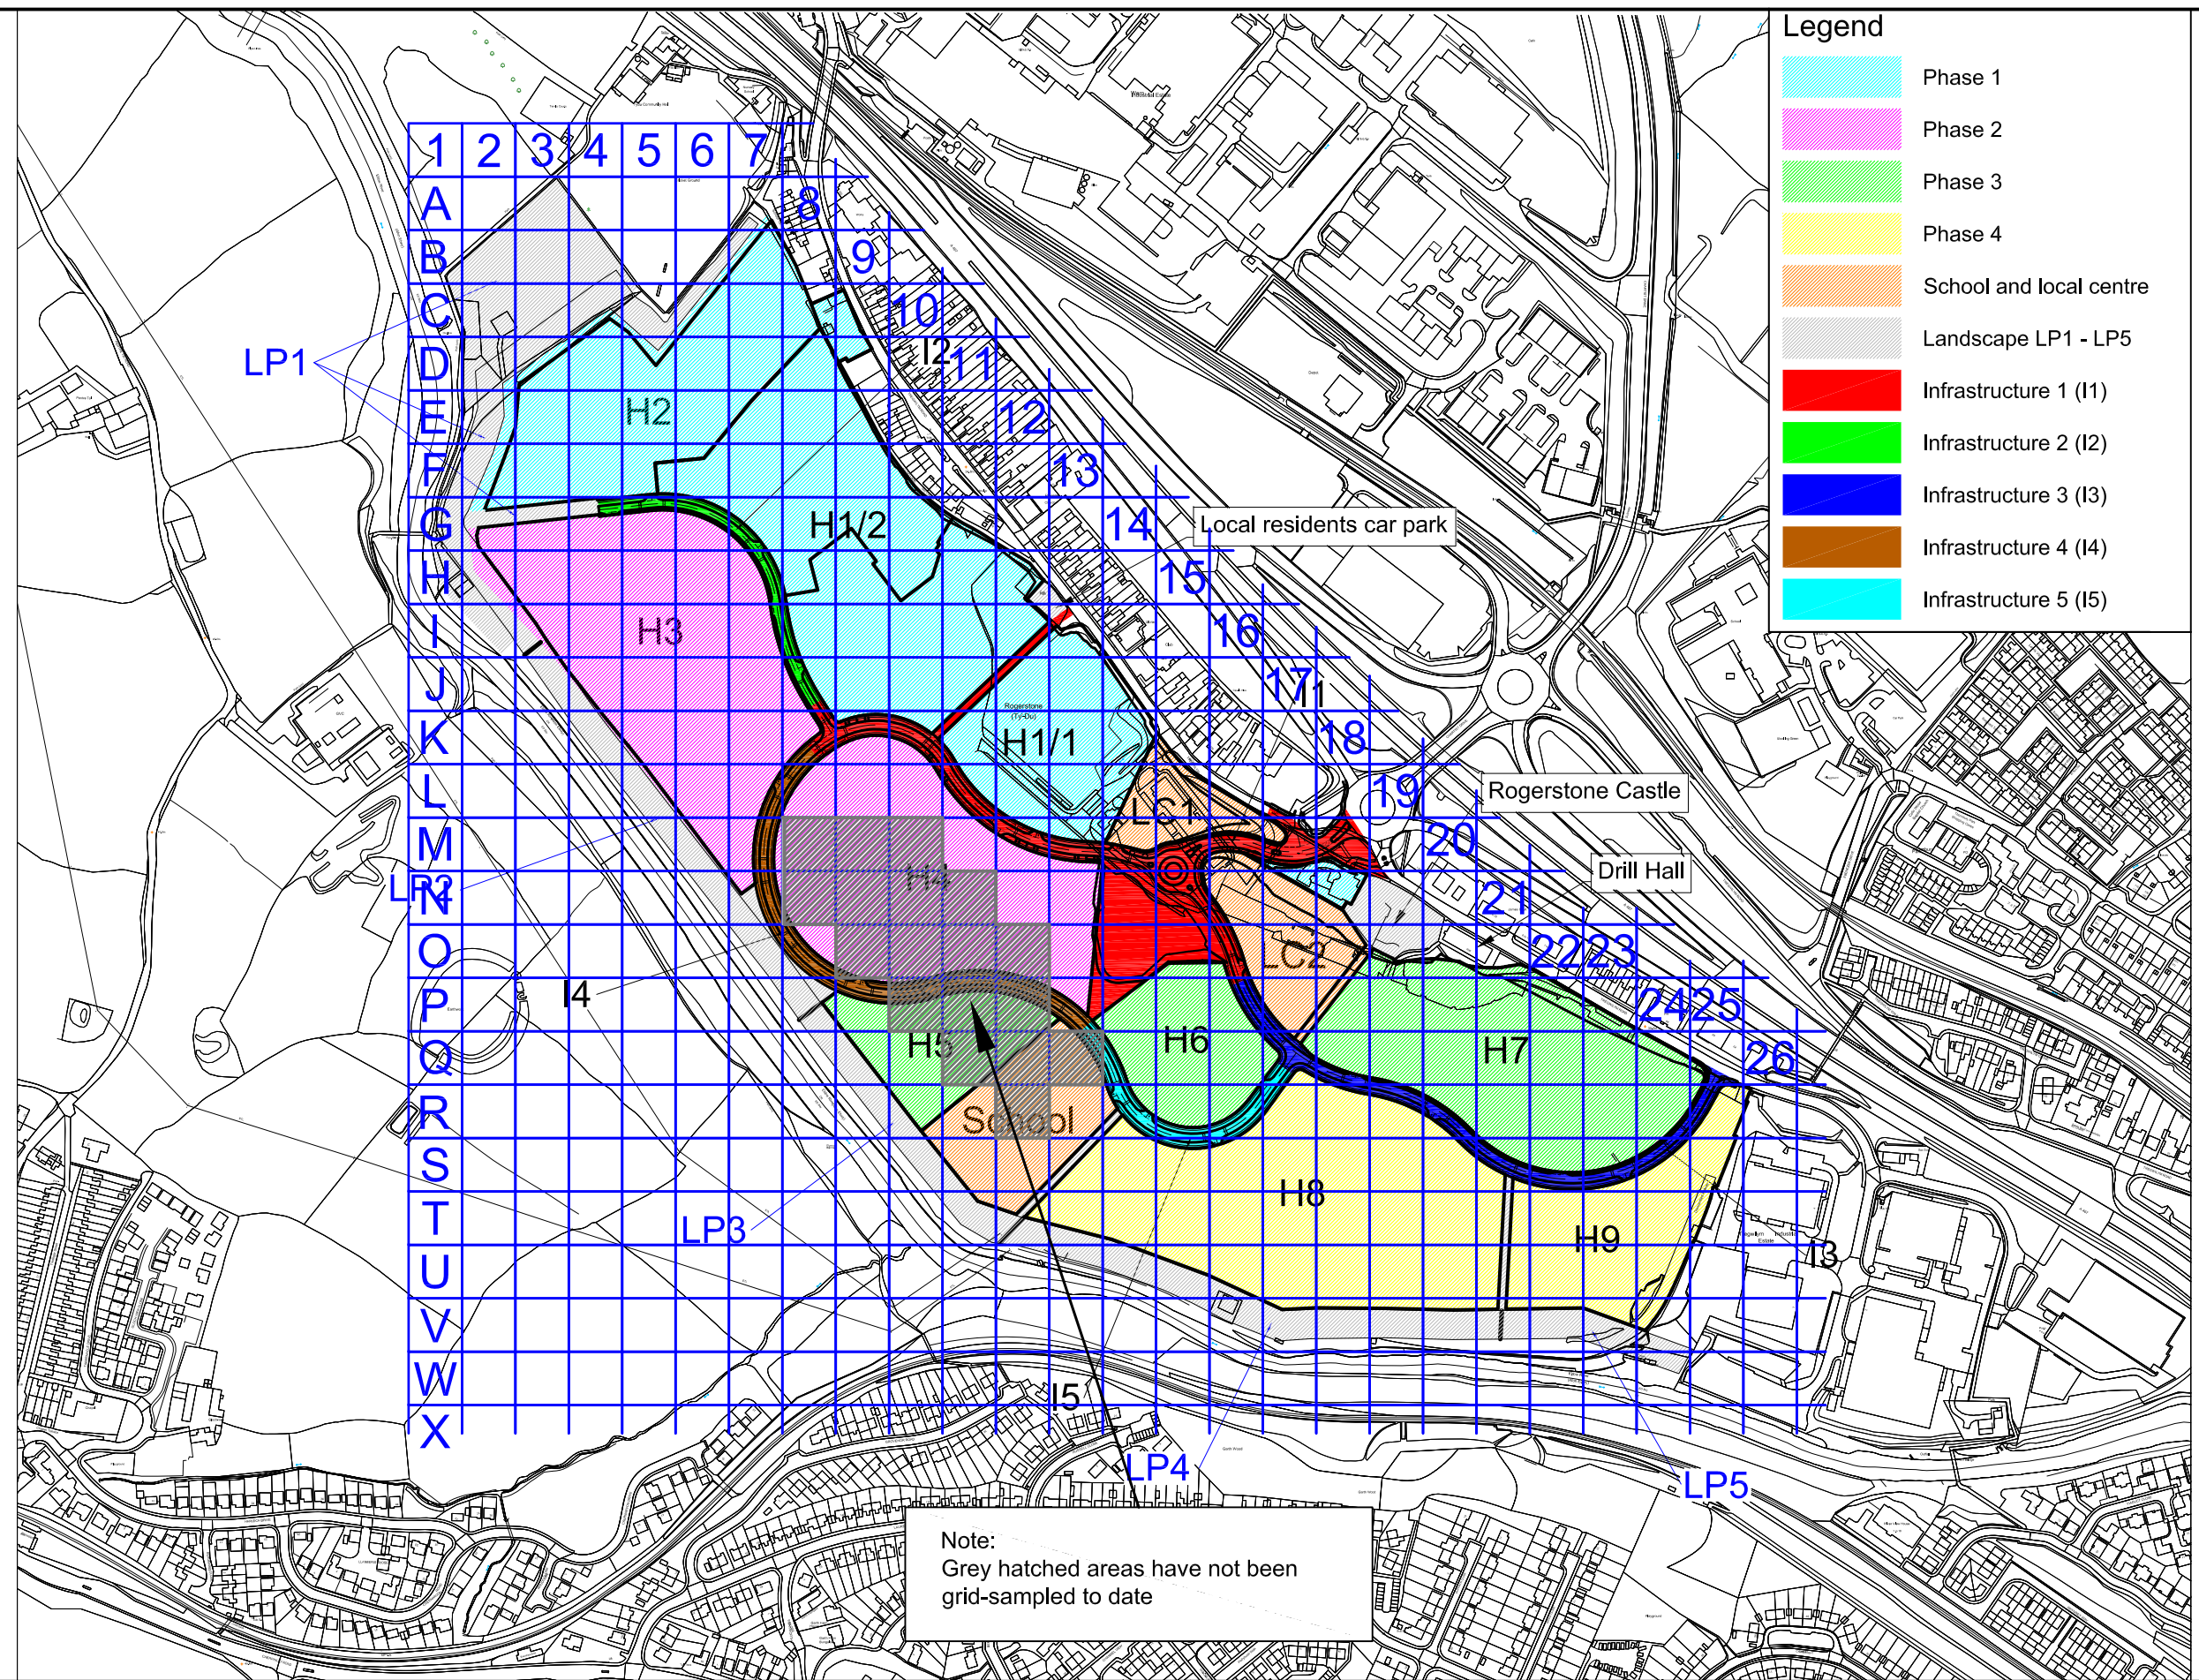
Figure 2: Site Plan

Copies of the trial pit logs relevant to land parcels LC1 and LC2, together with a copy of the site plan showing the respective trial pit locations/grid references are presented in Appendix A. The trial pits were excavated at the centre of the grid square and are referenced to that grid square (e.g.L15). The grid square locations are provided on the figure included in Appendix A.

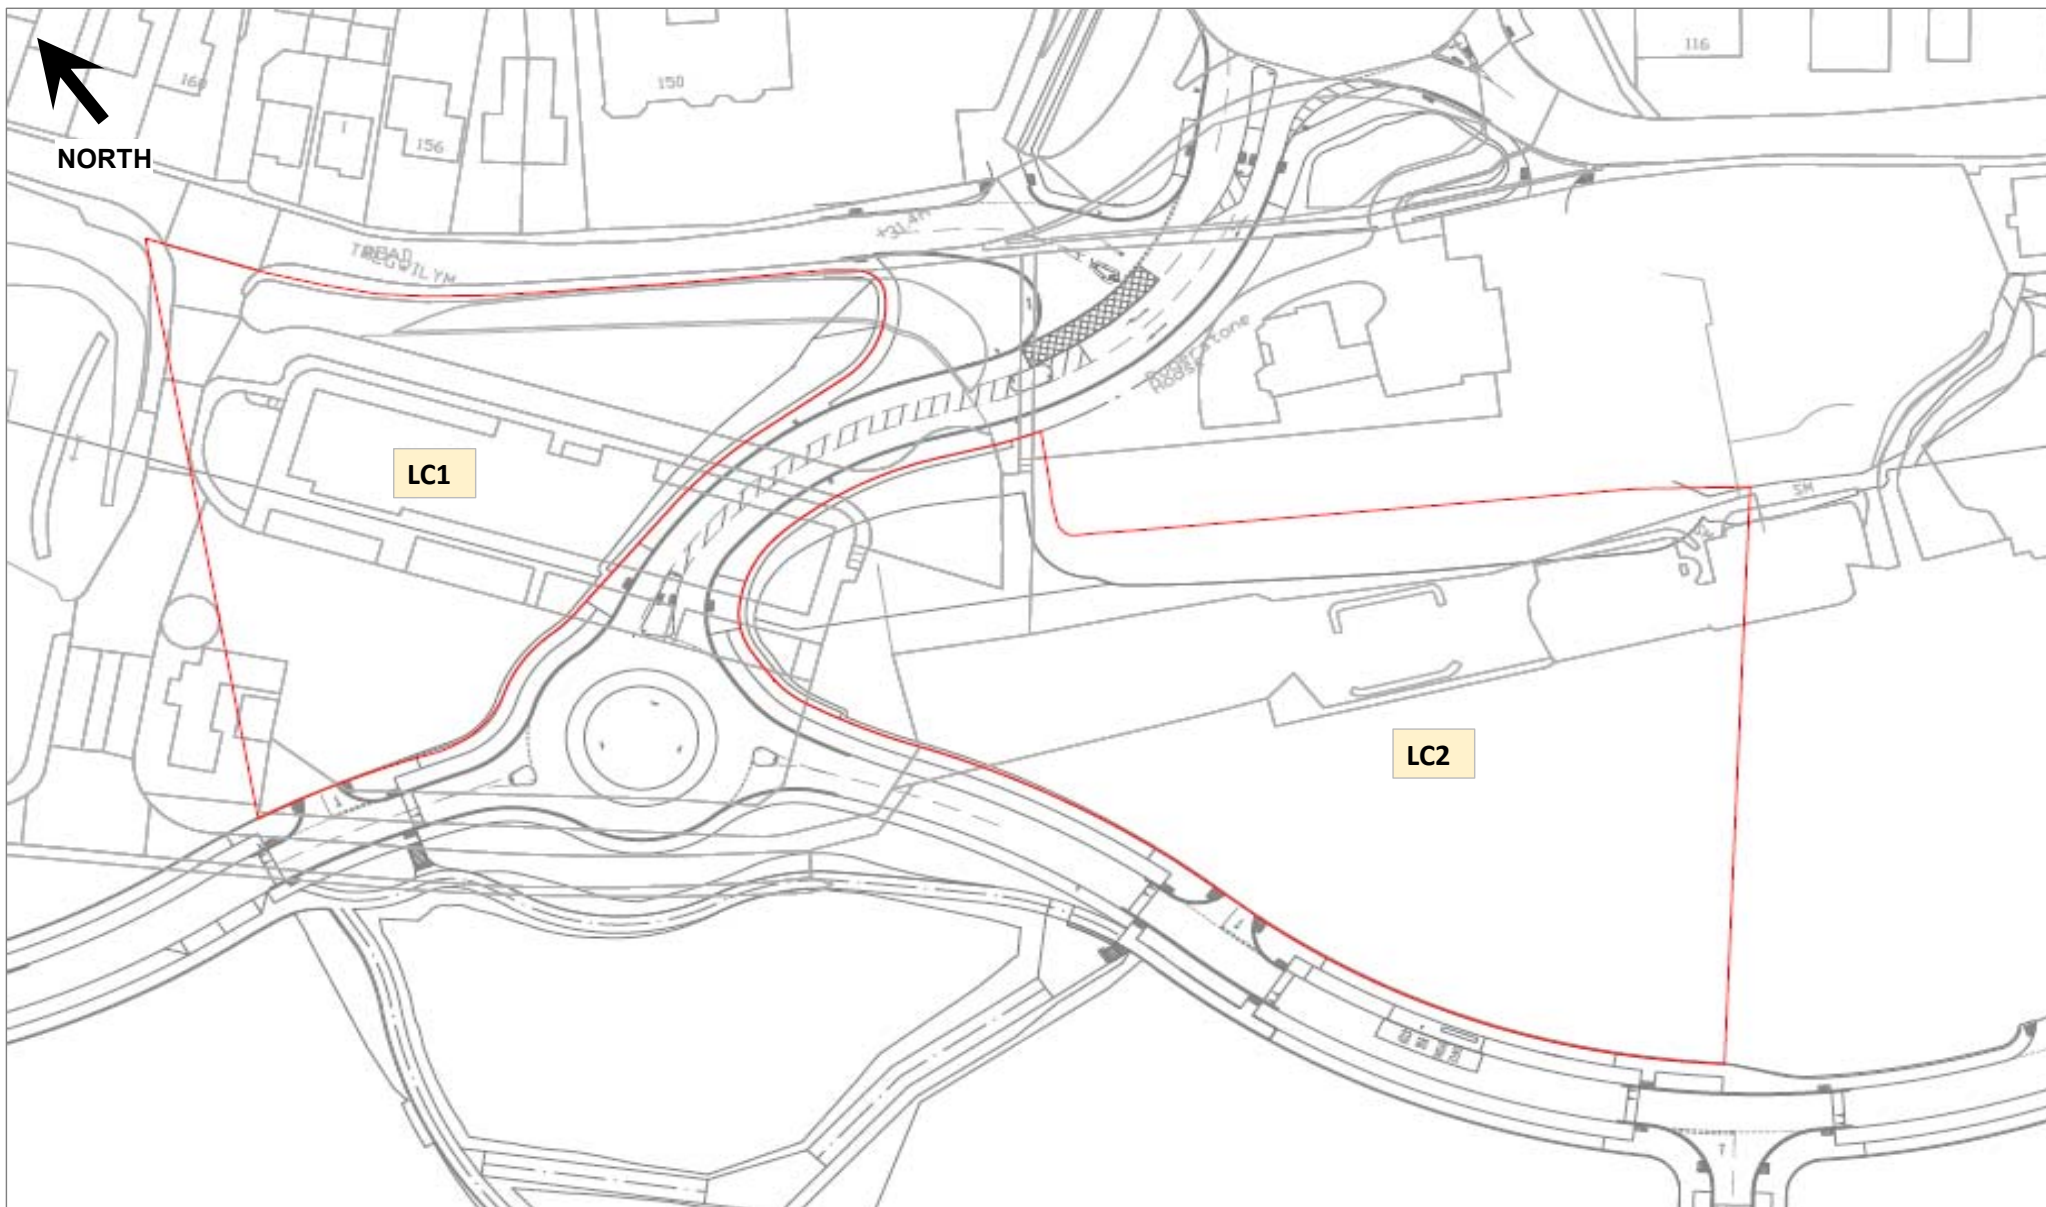
FIGURE 2: SITE PLAN

The two land parcels are separated by an existing access road and associated roundabout which provides access to the wider Jubilee Park development. Land parcel LC1 is located to the north of the road and land parcel LC2 is located to the south. A site plan is presented in Figure 2.

Walters Land (Rogerstone) Limited now propose a change in use for land parcels LC1 and LC2 from commercial end use to residential end use. The locations of LC1 and LC2 are shown on Figure 2.

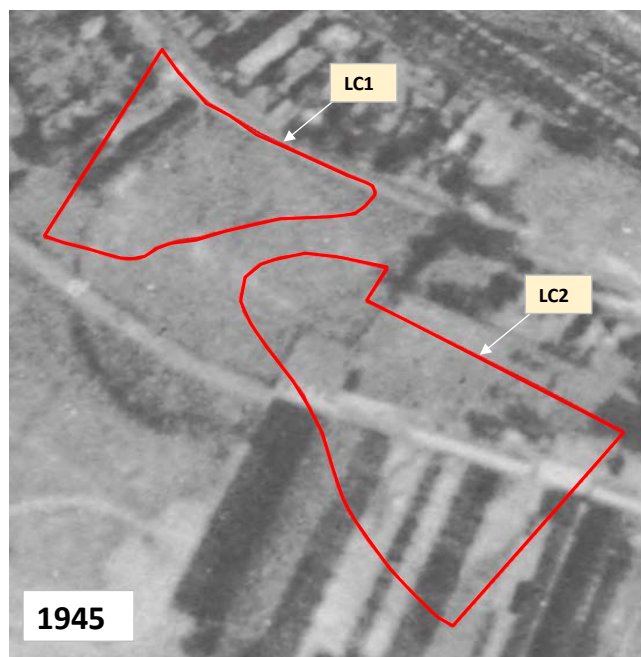
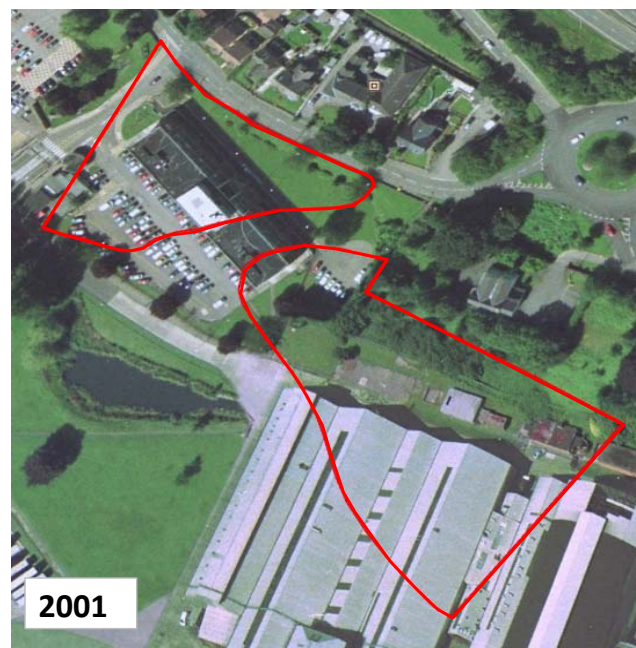
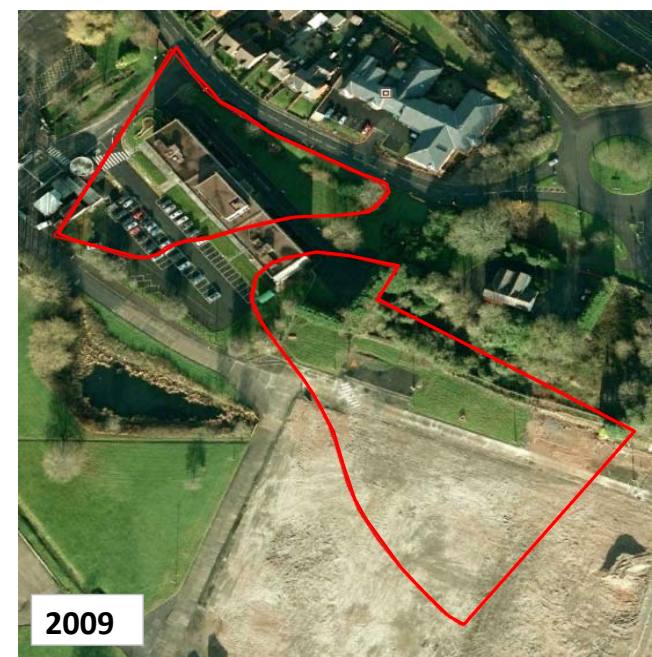
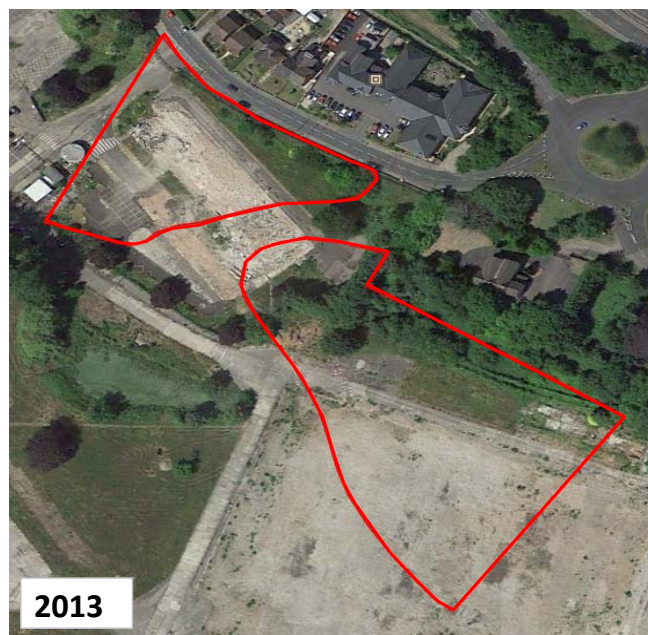
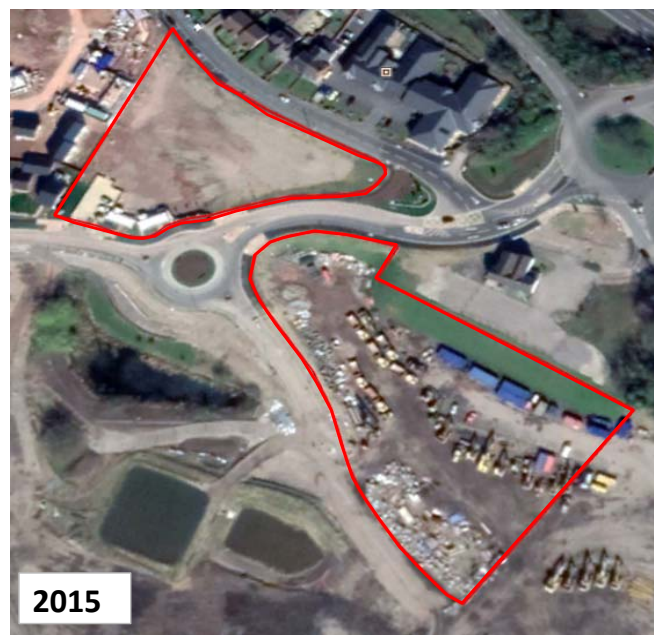
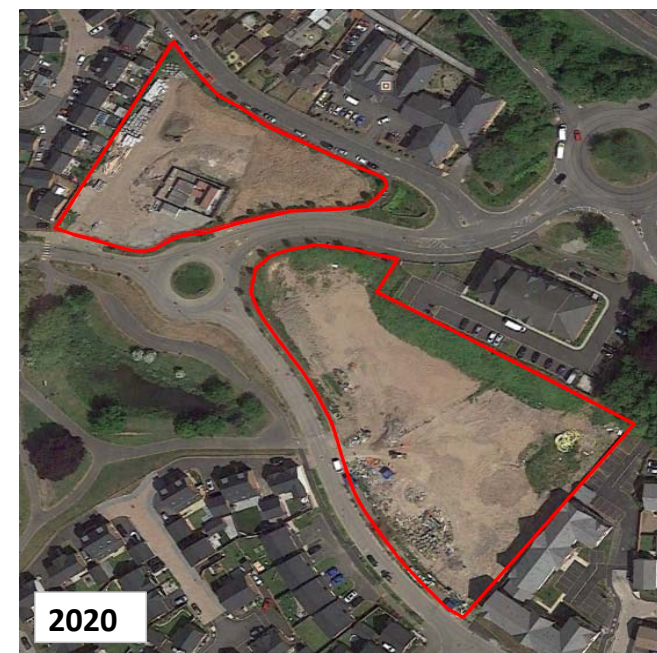
FIGURE 3: GOOGLE EARTH IMAGES

The 2009 Google Earth image indicated the east works buildings which crossed into LC2 to have been demolished. The office building and associated car parking area within LC1 remained.

By the 2013 Google Earth image the works buildings across the larger Jubilee Park area to the southwest of the site had also been demolished.

The 2015 Google Earth image indicated that the new estate access road had been constructed in between LC1 and LC2. At this time land parcels LC1 and LC2 were utilised as site compounds for the adjacent residential developments. The surrounding areas have continued to be developed for residential use up until the present day.

The aerial photo dated 1947 indicated the area of the former Castle Steel Works building to now have been redeveloped and the new building crossed the southern boundary of the LC2 area. The LC1 area remained undeveloped.
